Manhole Inspection Summary

Manhole # S43II_025MH

Insp Date: **4/25/08 8:40 AM**

Location Address: **Rutland Ave**

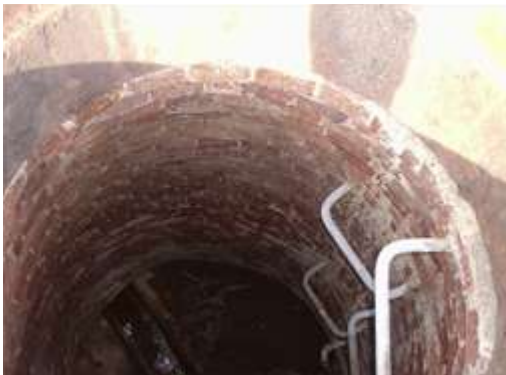
Defect 2

☒ **Leaks**

Frame Leaks

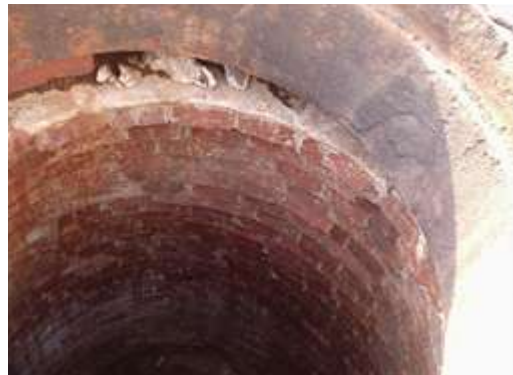
Defect 1

☒ **Loose Brick**

☒ **Deteriorated**

Deterioration

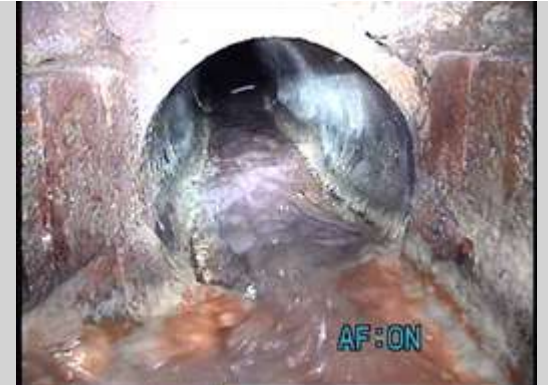
12 O'Clock Outflow

8 in. Circular Gravity Sewer
Pipe Out @ 12 O'Clock

Pipe Height: **8.4** (in.) Rod and Bar (Angled)
Pipe Material: **Clay** ☐ Pipe Lined
Invert Depth: **9.10** (ft.) Flow Characteristics: **Fast**
Deposits: ☒ None ☐ Mud ☐ Sludge ☐ **Debris** ☐ Grease
Silt Depth: (in.) Deposits Extent:
Infiltration: **None** Pipe Seal Cond: **Sound**

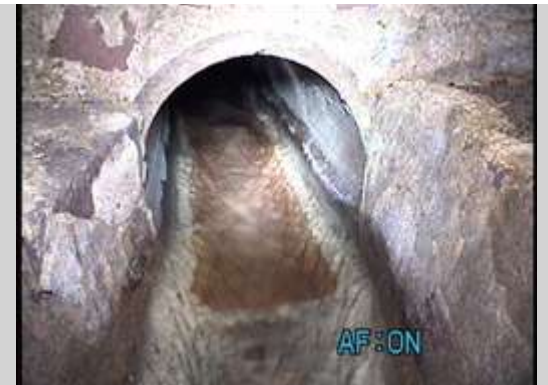
4 O'Clock Inflow

8 in. Circular Gravity Sewer
Pipe In @ 4 O'Clock

Pipe Height: **8.4** (in.) Rod and Bar (Angled)
Pipe Material: **Clay** ☐ Pipe Lined
Invert Depth: **8.70** (ft.) Flow Characteristics: **Fast**
Deposits: ☒ None ☐ Mud ☐ Sludge ☐ **Debris** ☐ Grease
Silt Depth: (in.) Deposits Extent:
Infiltration: **None** Pipe Seal Cond: **Sound**

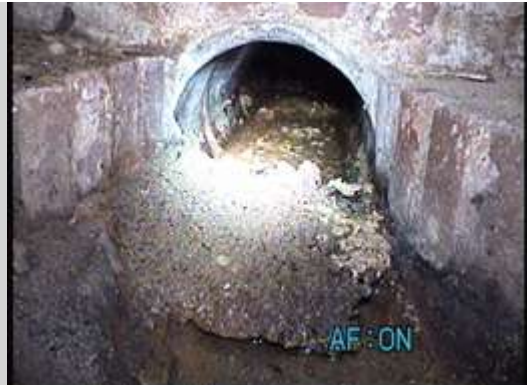
9 O'Clock Inflow

Deposits: ☐ None ☐ Mud ☐ Sludge ☒ **Debris** ☐ Grease

Silt Depth: **2** (in.) Deposits Extent: **Light**
